**Hubert Melges\*, Małgorzata Melges\*\***

## *The principle of building processes staging during the renovation of church towers and the exchange of a roof framing in neo-Gothic St. Martin Church in Krzeszowice*

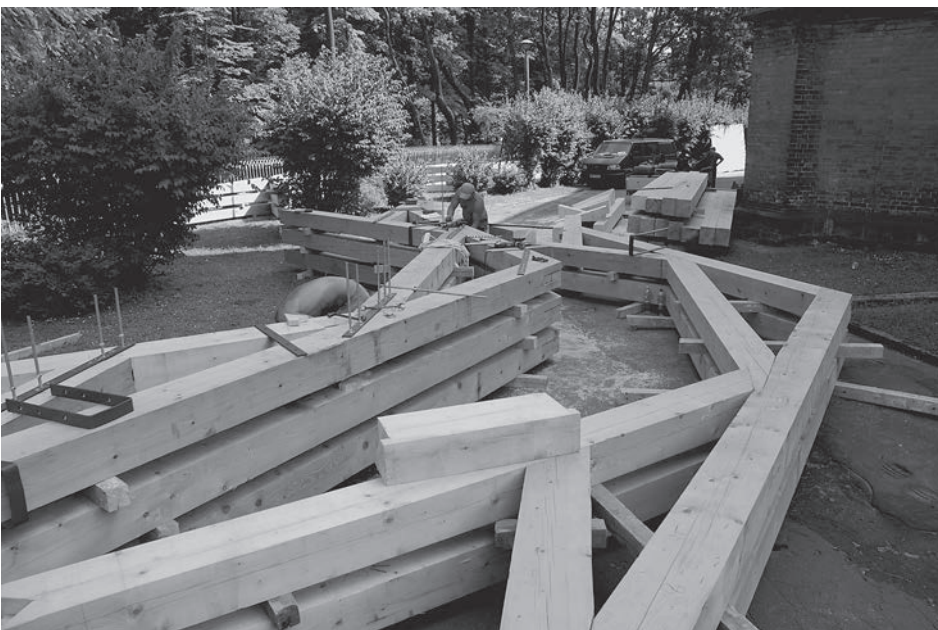
Fig. 2. Execution of the reconstructed roof framing trusses

A necessary restoration requirement was a total and exact reconstruction of the roof truss (of all elements and details along with carpenter's joints). It should also be mentioned that the size of wood in the roof truss was, for example, 25×31 cm. The size and weight of these elements caused many difficulties in the execution of the works. On the designated place outside the church, a special wooden platform was made in order to conduct on it a precise process of fixing the roof trusses. All parts of the roof trusses were made on the basis of the previously detailed inventory. The smallest mistake or inaccuracy could rule out a possibility to conduct the process of fixing and connecting the roof trusses with other elements of the roof framing construction. The reconstructed elements of the roof framing were numbered and described and then the roof construction trusses were put together according to the principle regarding the roof truss typing, which was established some time earlier. The sizes of the roof trusses were very big; therefore, they had to be taken apart in order to be transported to the church. Finally, the process of the whole construction fixing took place at the yard near the church. The particular roof trusses were fixed by means of the crane according to an established order.

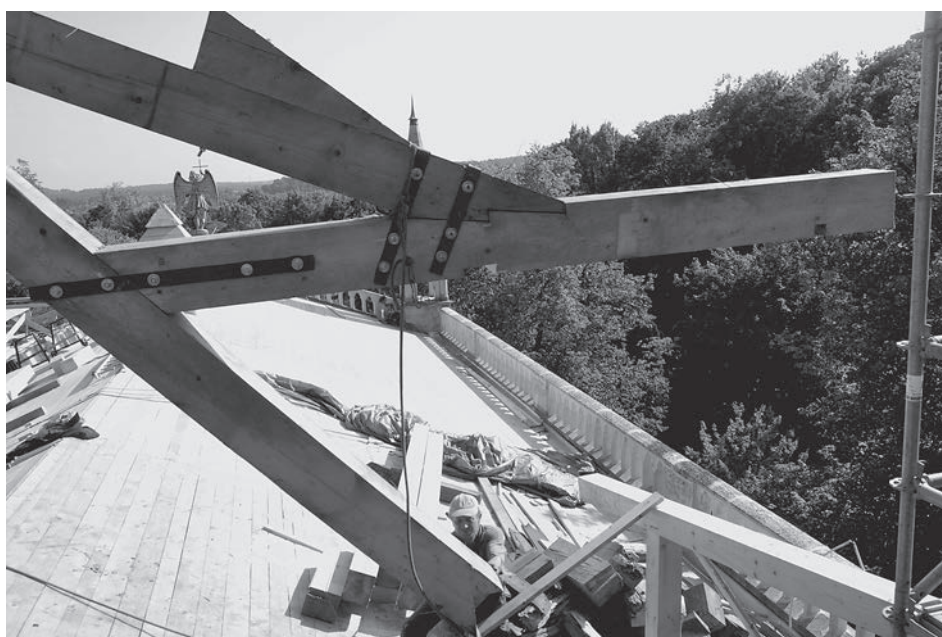
Fig. 3. Fixing the roof truss on the wall crown

The roof trusses were additionally reinforced by means of special steel anchors which were regained after the removal of decapitalized elements of the roof framing. Owing to the necessity of guaranteeing safety and in order to avoid roof leaks (taking into account the weather anomalies, the year 2010 was not conducive to the execution of such works), the old elements were replaced by the new reconstructed elements after the preparation of the background (plates, floor beams) and the reinforcement of the walls crown. During the execution of the works, absolute precision was required with error tolerance of some millimetres.

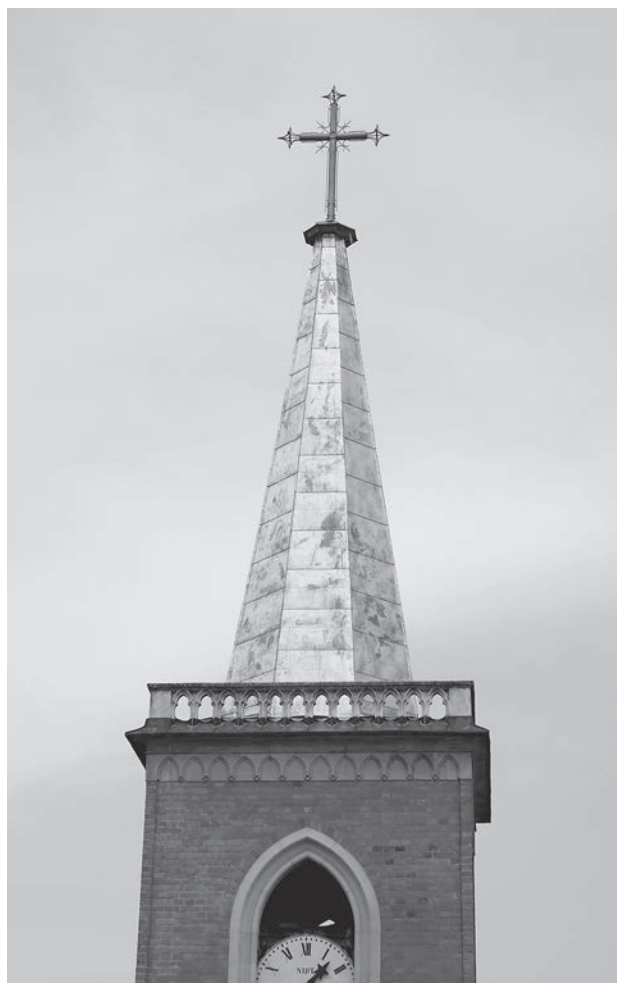
Fig. 5. Final stage of the tower copula renovation surmounted by the cross

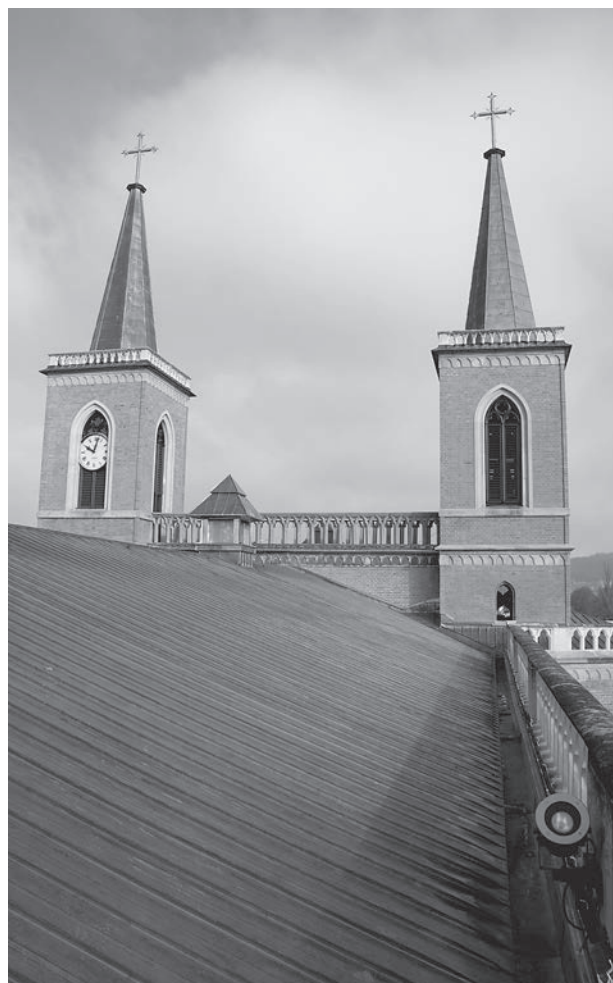
Fig. 6. Final view of the roof slope after renovation
