The principle of building processes staging during the renovation of church towers and the exchange of a roof framing in neo-Gothic St. Martin Church in Krzeszowice

Restoration and building issues in St. Martin Church in Krzeszowice

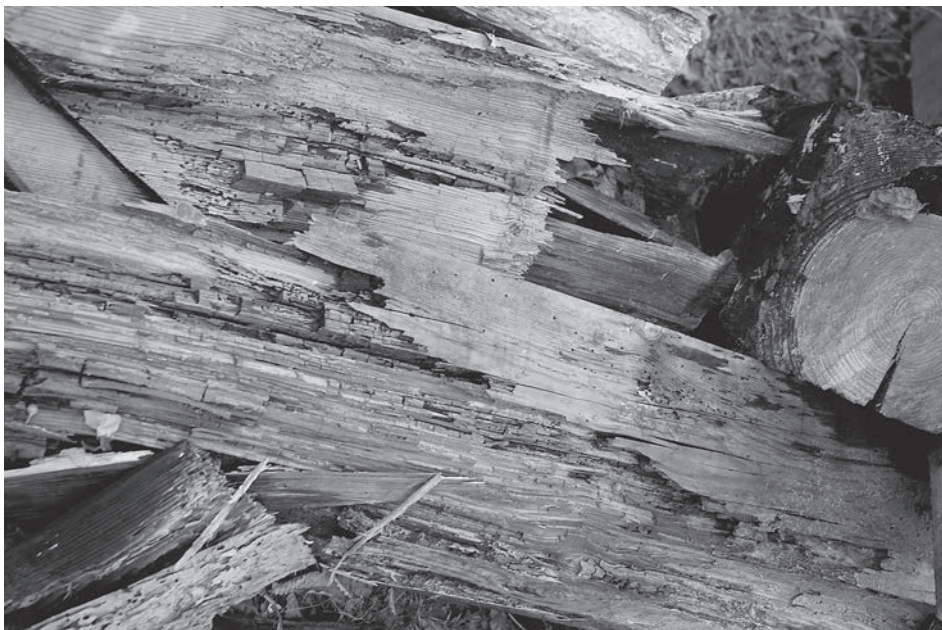
Fig. 1. Fragment of the destroyed roof framing construction

zation processes of the roof framing and cover. On the basis of this inventory, thorough entomological, phytopathological and mycological examinations of fungal condition and the extent of destruction of the wooden elements of the church roof framing were conducted. When the level of destruction of the roof framing constructional elements was specified, a constructional expertise of the roof framing technical condition was provided. Entomological and phytopathological examinations confirmed high biological wood corrosion where constructional elements were depreciated in large parts by the fungus *Coniophora cerebella* which caused brown decay as well as destructive presence of vermin called old-house borer (*Hylotrupes bajulus* L) and house grinder. Additionally, growing moulds from Micromycetes class caused complex processes of biologically depreciated elements of the roof framing [1].

On the basis of the total number of expertises and the level of damage of particular constructional elements it was ascertained that circa 60% of the construction wood was worn out and consequently the final decision was taken as to a complete replacement of the roof framing. During a demolition of the roof framing and a detailed analysis of technical condition wear and tear, it turned out that the particular constructional elements are damaged in 70%. Finally, on the basis of the inspection carried out by Provincial Monument Protection Organisation in Cracow the Restoration Opinion was issued which gave permission to conduct the renovation works. Thanks to these preparatory procedures, the parish was able to apply for a renovation works subsidy in the Ministry of Culture and National Heritage from the program of Cultural Heritage as a priority of Monuments Protection. The whole

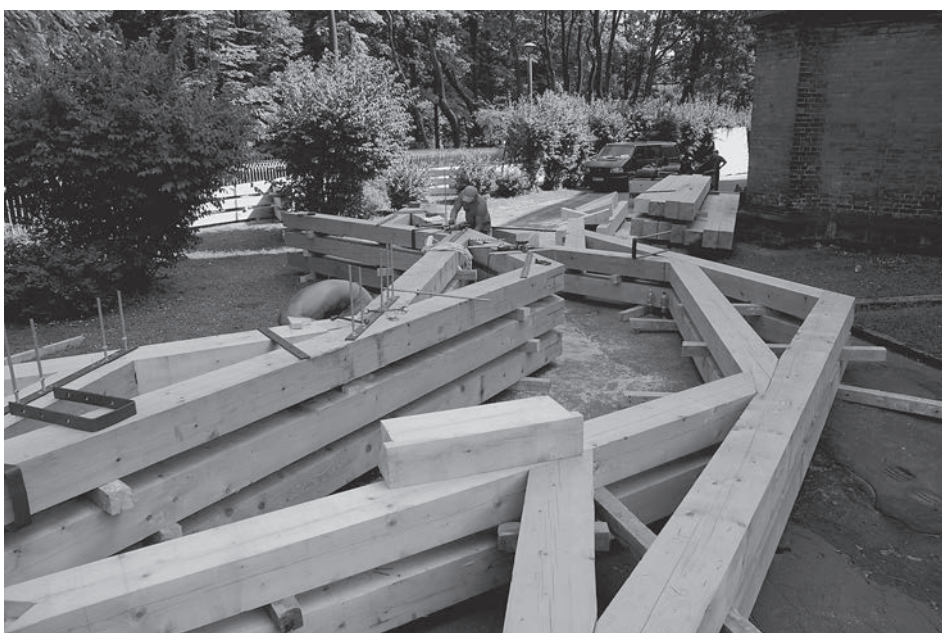
Fig. 2. Execution of the reconstructed roof framing trusses

A necessary restoration requirement was a total and exact reconstruction of the roof truss (of all elements and details along with carpenter's joints). It should also be mentioned that the size of wood in the roof truss was, for example, 25×31 cm. The size and weight of these elements caused many difficulties in the execution of the works. On the designated place outside the church, a special wooden platform was made in order to conduct on it a precise process of fixing the roof trusses. All parts of the roof trusses were made on the basis of the previously detailed inventory. The smallest mistake or inaccuracy could rule out a possibility to conduct the process of fixing and connecting the roof trusses with other elements of the roof framing construction. The reconstructed elements of the roof framing were numbered and described and then the roof construction trusses were put together according to the principle regarding the roof truss typing, which was established some time earlier. The sizes of the roof trusses were very big; therefore, they had to be taken apart in order to be transported to the church. Finally, the process of the whole construction fixing took place at the yard near the church. The particular roof trusses were fixed by means of the crane according to an established order.

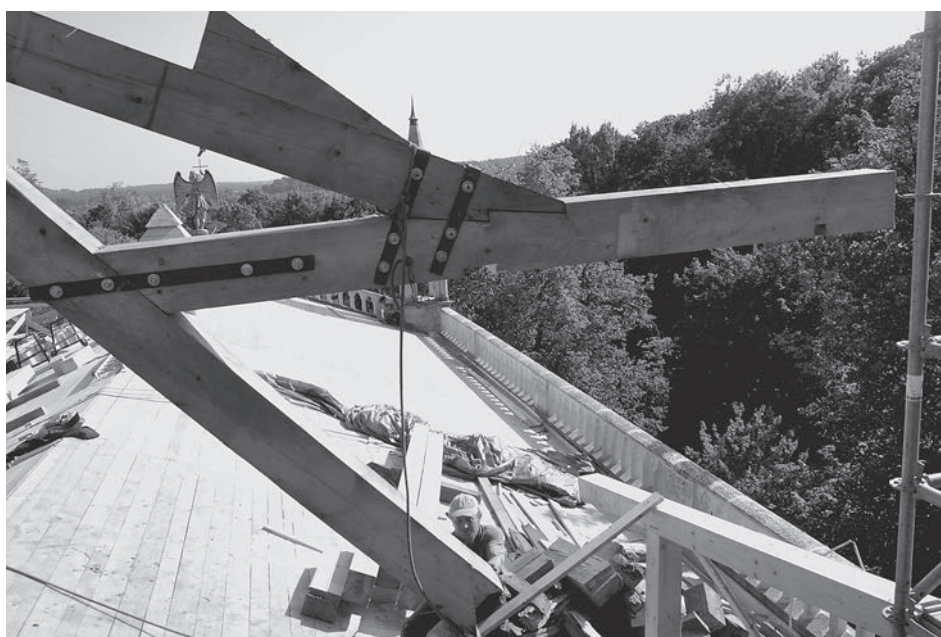
Fig. 3. Fixing the roof truss on the wall crown

The roof trusses were additionally reinforced by means of special steel anchors which were regained after the removal of decapitalized elements of the roof framing. Owing to the necessity of guaranteeing safety and in order to avoid roof leaks (taking into account the weather anomalies, the year 2010 was not conducive to the execution of such works), the old elements were replaced by the new reconstructed elements after the preparation of the background (plates, floor beams) and the reinforcement of the walls crown. During the execution of the works, absolute precision was required with error tolerance of some millimetres.

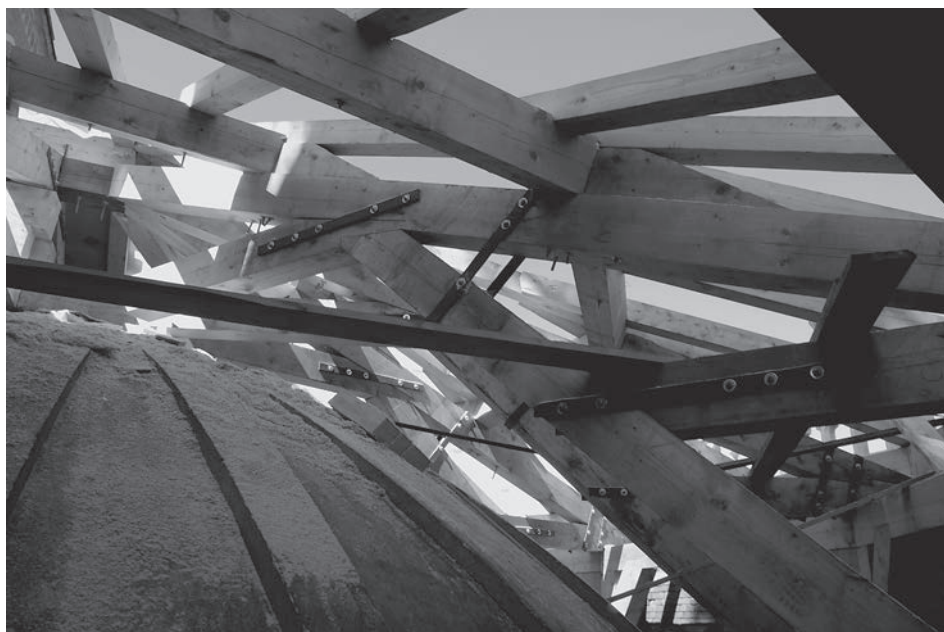
Fig. 4. One of the fixing stages of the roof truss above the presbytery
