**Malgorzata Melges\*, Hubert Melges\*\***

*Research method in recognizing the causes  
and level of destruction of the roof construction  
in the neo-Gothic 19<sup>th</sup> century St. Martin's Church in Krzeszowice  
designed by Karol Fryderyk Schinkel*

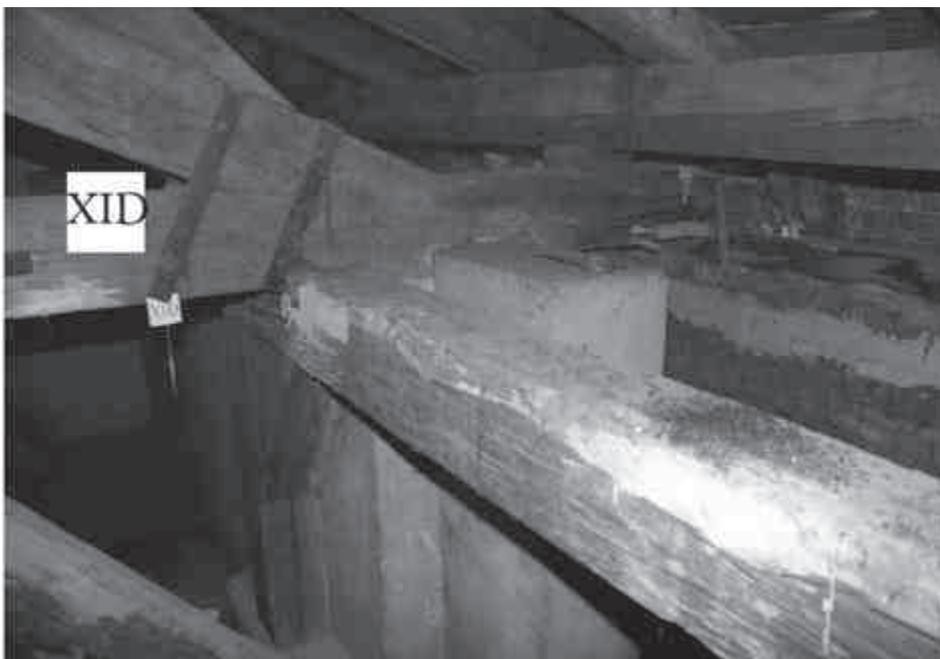
Fig. 4. Markings of various types of main trusses and places of destruction
