**Malgorzata Melges\*, Hubert Melges\*\***

*Research method in recognizing the causes  
and level of destruction of the roof construction  
in the neo-Gothic 19<sup>th</sup> century St. Martin's Church in Krzeszowice  
designed by Karol Fryderyk Schinkel*

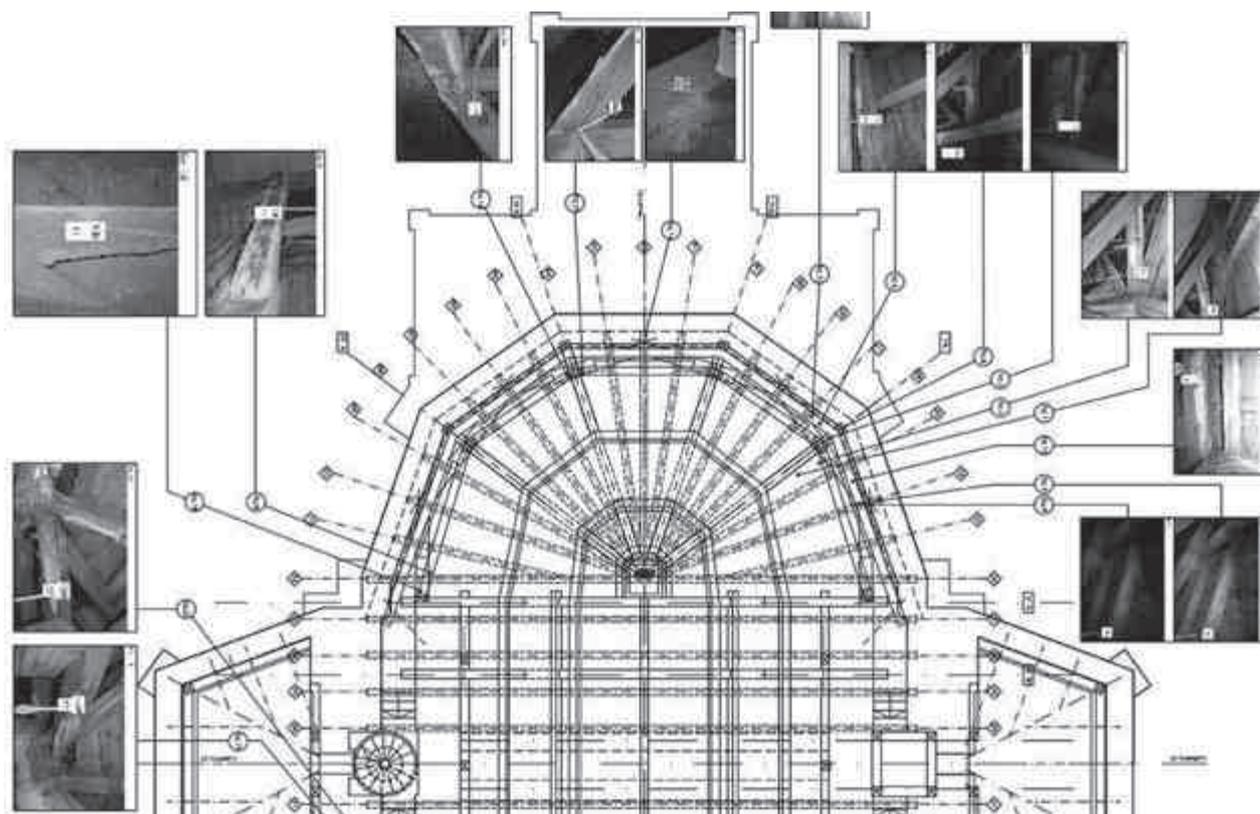
Fig. 5. Fragment of roof truss projection with the accepted system of markings in relation to research cards

method significantly facilitated the detection of damaged places and their scope. Because of very special and unusual joints and woodwork connections, all details required a careful analysis, inspection and measurement from all sides with the use of traditional manual technique. What proved especially helpful in recognizing the complicated woodwork details was the free-hand sketches drawn in perspective which helped to precisely reconstruct the original roof framing. The complicated system of the main trusses, which were applied in different variations, required a precise determination of different gradients of the roof planes above the nave and the chancel as well
