Roman Kinash*, Tadeusz Kamisiński, **,
Adam Pilch*, Jarosław Rubacha***

Acoustic aspects of the Lviv Theatre of Opera and Ballet auditory usage

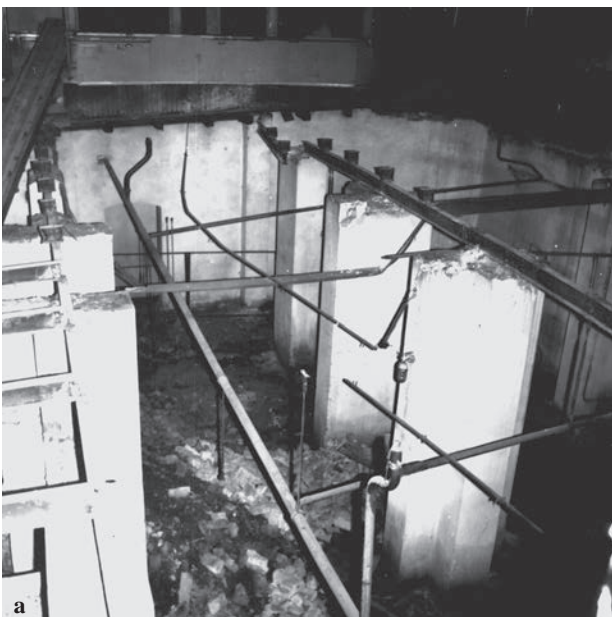
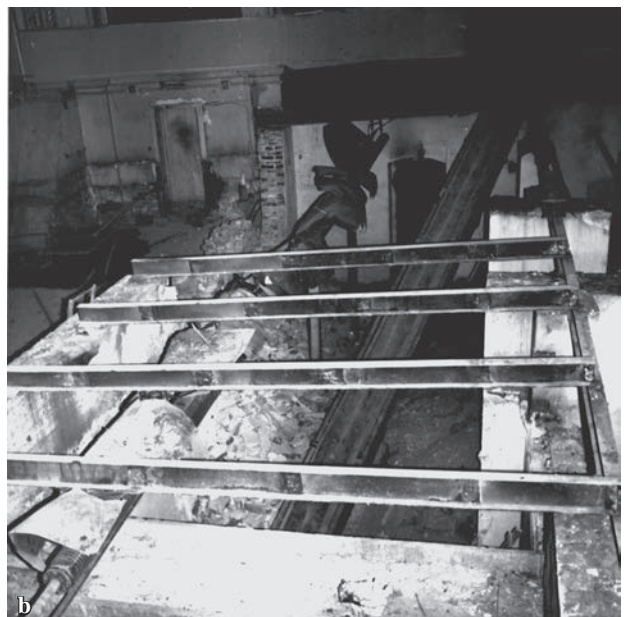
Fig. 2. Replacement of floor construction in 1980: a) view of disassembled floor construction; b) floor construction metal I beams

Over the last few years, after a period of neglect, the building has been successively renovated and its original magnificent auditorium has been restored with the use of modern technology. In 1980, the first modernization was conducted. It included a replacement of the metal construction of the floor with concrete floor covered with pinewood boards on joists (Fig. 2, p. 246). At that time the boxes were decorated with lambrequins, which negatively affected the acoustics of the hall. Artists complained that the voice and music performed in the theater sounded more dull, which was caused by an increased absorption of high frequencies by soft elements. Due to the lack of acoustic documentation from that time it is impossible to objectively determine the impact of the first renovation on the interior acoustics. In order to eliminate the possibility of negative impact of the next modernization on the acoustics, their test was commissioned before the commencement of the renovation. The replacement of floors and renovation of the interior was scheduled to be conducted during the summer break in 2008 [8].

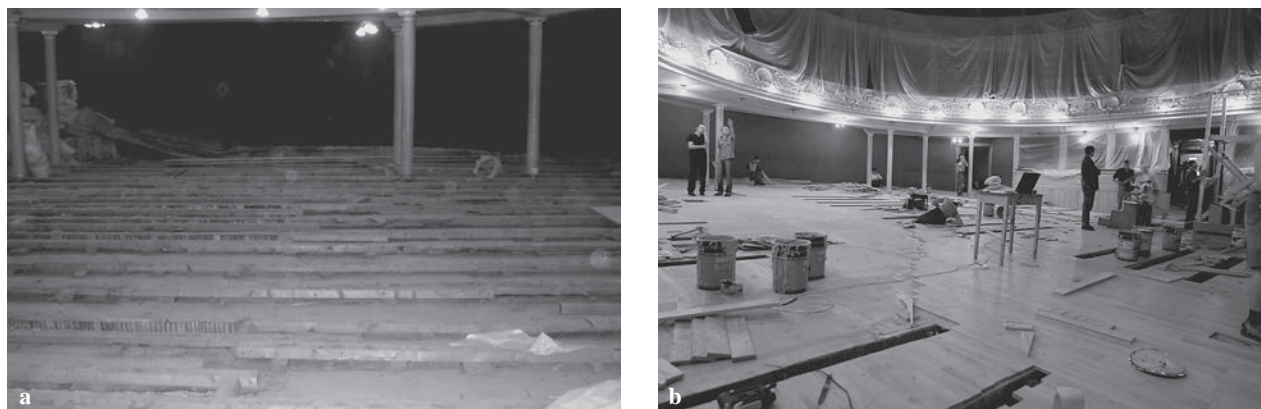
Fig. 3. Replacement of floor construction in 2008:
a) floor joists placed on reinforced concrete floor; b) parquet floor boards on plywood and joists

qualities was specified [5]. It was found that the solution planned by the investor, consisting in laying oak parquet on pinewood boards would decrease the acoustics of the hall. It was suggested that the boards be replaced with thin plywood, decreasing the gap between parquet and the reinforced concrete slab and sound dispensers be installed on the back wall of the cavity under the balcony [7].

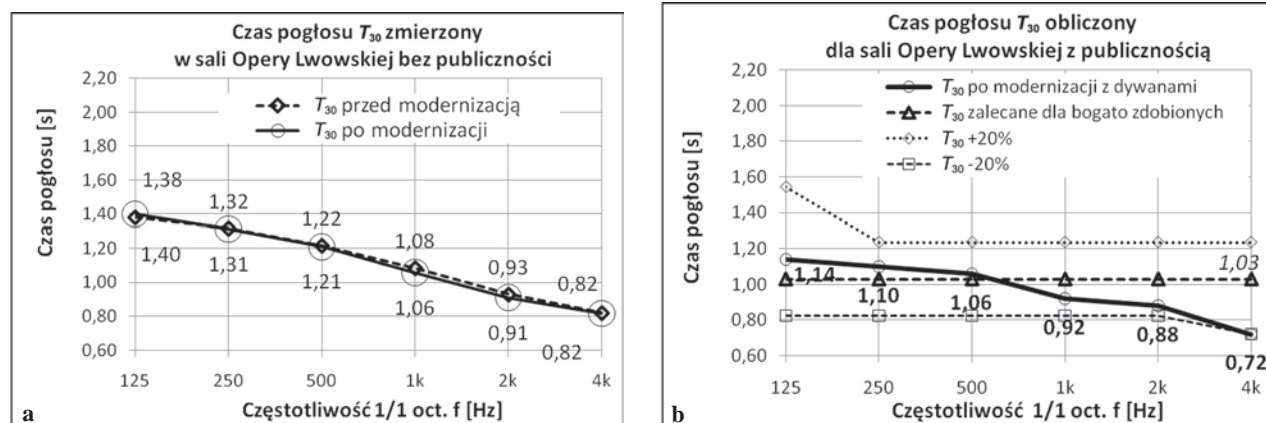
Fig. 4. The Lviv Opera – real and simulated average value of the reverberation time T_{30} depending on frequency:
a) measured; b) from computer simulation

Analysis of the diagram in Fig. 4a demonstrates that the reverberation time characteristics have not significantly changed after the renovation, however, the slight differences which have been detected between the characteristics are within expected tolerance. The correct selection and application of the floor layers, carpets and lambrequins had the most evident influence on the maintenance of the original acoustics of the hall after modernization. The values measured before and after modernization as well as the results of the simulation of the parameters are very similar

and they fall within the scope marked in Fig. 4b. of the values recommended for opera halls, so it was possible to assume that the acoustics of the renovated interior would be positively received by the performers and listeners. The measurements conducted after modernization confirmed the correct selection of new materials and the compliance of the numerical model with reality. The positive reception of the acoustics of the renovated interior by the performers and listeners enabled the final determination of the correctness of the measurements and the simulation.

Figure 4 shows the real/measured (4a) and computer simulated (4b) average values of the reverberation time T_{30} for the auditorium of the Opera. Fig. 4b shows also the method of assessment of the reverberation time characteristics developed for the opera interiors with rich decorations [6]. The theater interiors designed on a horseshoe plan with carpets, lambrequins and rich upholstery demonstrate shorter reverberation time than it is assumed in literature for theaters. Figure 5 shows a simulated distribution of STI parameter in the auditorium before and after modernization. An improvement of the speech transmission quality in the middle section of the auditorium on the ground floor is evident. A decisive majority of the seats in the auditorium has STI parameter within the scope of good speech transmission.
